Geological and Geomorphological Hazard in Historical and Archaeological Sites of the Mediterranean Area: Knowledge, Forecasting and Mitigation

Abstract

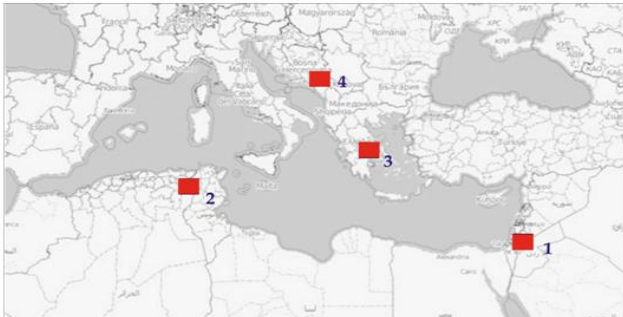
Figure 1: Geographic location of the studied sites.
Legend: 1) Petra; 2) Dougga; 3) Delfi; 4) Montenegro coastal centers

The programme has required analysis and control supported by data processing systems and ultimate generation technology of space mapping. More than 20 sites have been studied in all (Fig. 1) from north to south: Lorca (Spain), some coastal centres in Montenegro (Cattaro, Budva, Bar and Ulcinj), Delphi and Parga (Greece), Butrint (Albania), Epheso and Cappadocia rocky settlements (Turkey), Petra (Jordan), Dougga (Tunisia), as well as some Italian centres that have been damaged by various seismic and hydro geological calamities.

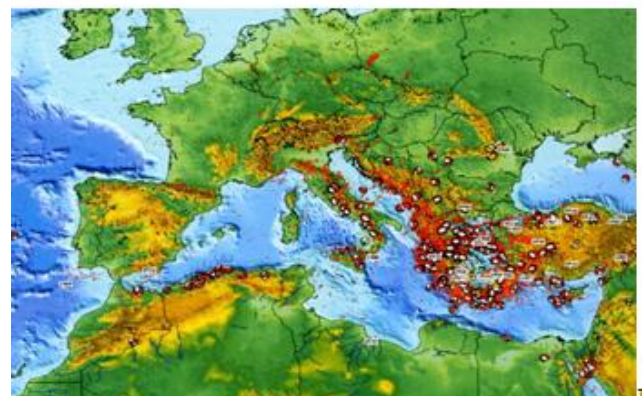
Figure 4: Seismicity in the Mediterranean area with epicentres of Ms>4 recorded from 1961 to 2004¹

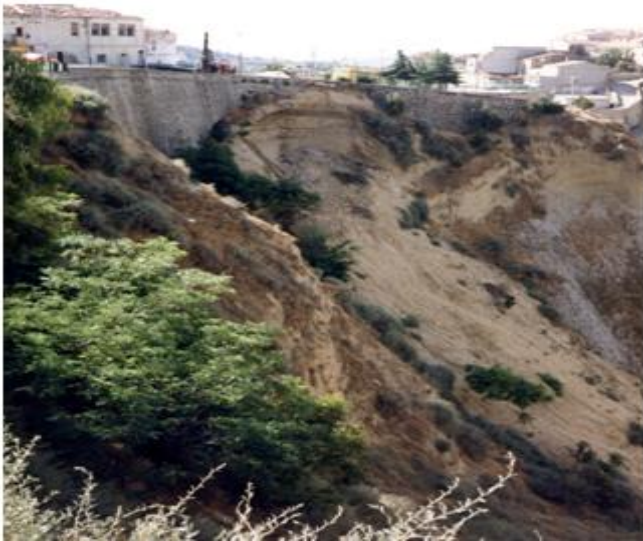
Figure 6: Example of mudflow landslide in Aliano built-up area in Basilicata region activated by the earthquake on 23 November 1980

The slope dynamics is more active in case of particular geological-structural settings and during extreme rainfall events. Heavy rains in a short time, typical of a dry-temperate Mediterranean climate, erode and undermine slopes. The most disadvantageous structural-geological conditions mainly characterised by clay deposits are subjected to compressive and distensive tensions that have slightly modified the mass structure and consistency often affected by deformations and tectonic displacements¹². In these environments, a wide range of gravitational events occur due to erosion and mass movements (Fig. 6).

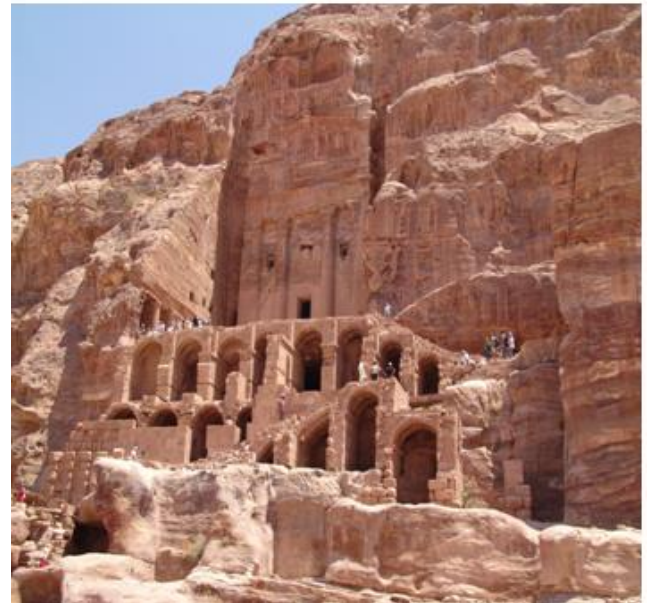
Figure 8: Erosion and rock falls at the Tomb of the Urn Complex in Petra

Examples of whole slopes collapse with serious damages on monuments are quite numerous and could increase over time above all in absence of interventions for their protection and static recovery. The Urn Tomb has been identified as one of the most important monuments at risk. Actually, intense erosions together with initial collapses of rock and physical-chemical deterioration of the surface layers could soon determine the loss of the monuments (Fig. 8). Several solutions to limit and stop gravitational and erosive processes in Petra, often irreversible, can be adopted but involving high economic charges of which only the international community can make itself responsible in order to apply historical heritage protection policies.

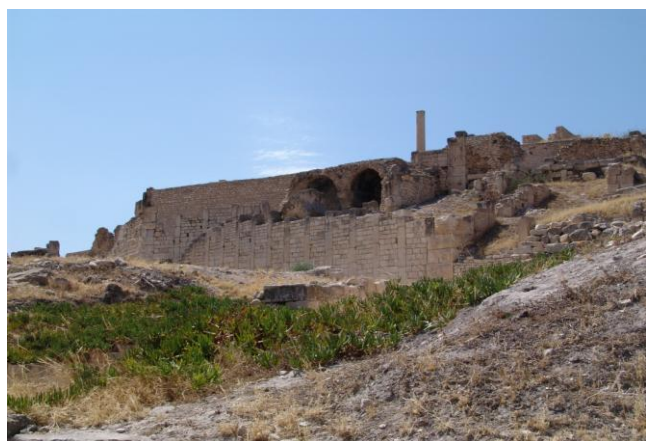
Figure 10: Appearance of the unstable area with ancient retaining walls (Dougga). In the foreground the outcrop of plastic clays is seen

be deformed as regards to slight thrusts. This terraced configuration caused a series of changes and unbalances within the distribution of loads in depth especially in the medium-low part of the town where incoherent clay gravelled soils prevail (Fig. 10).

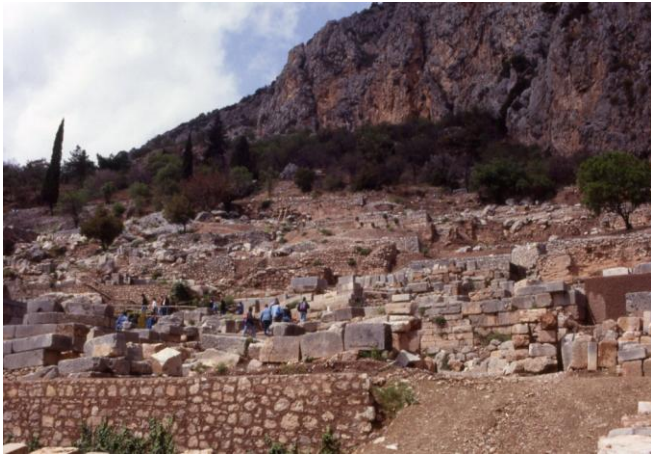
Figure 12: Overview of Delphi's archaeological area with wide outcrops of debris and collapses occurred in fractured limestones

expanded uphill where Greek cities erected some buildings containing votive offerings called “thesaurai”. The site overlooks the Pleistos valley and is dominated by steep and tall rocks called “Phedriades” that form the springs of Castalia from which a holy spring originates (Fig. 12).

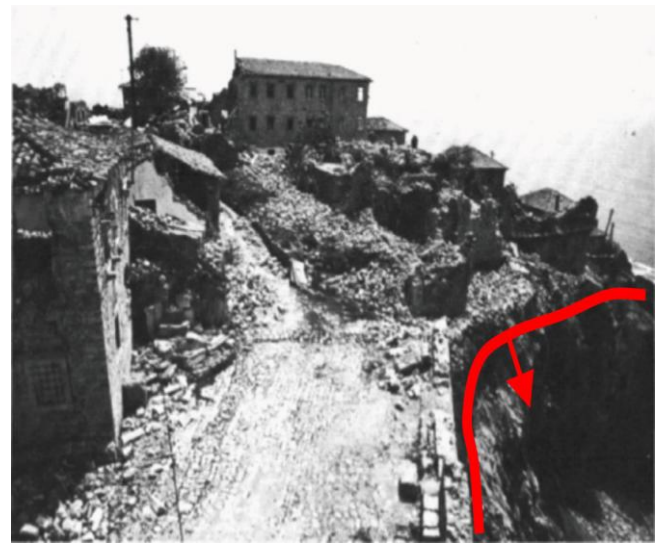
Figure 14: Historical image representing the half-destroyed village upstream of Cattaro because of an earthquake occurred on May 29, 1979. On the right, rockfalls triggered by the earthquake are also showed

The area is within a very complex territory from the point of view of the geomorphological and seismic dynamics. It is located in the middle-southern dinaric region along the eastern border of the Adriatic plate where there is an accentuated seismic shaking with medium-high magnitude values (Fig.13). Moreover, the prevailing geological successions are very tectonized and with low resistance values so that the activation of landslides is frequent and dangerous. More precisely, the coastal area of Montenegro belongs to the perimediterranean zone that marks the tectonic limit between the Euro-Asian plate and the African one, where a strong seismicity is concentrated with a high frequency of events with $M_s > 4$. For example, in the southern Dinarides between 1823 and 1979, 10 seismic events occurred with a magnitude comprised between 5,9 and 6,7. They caused damages more or less serious to the inhabited settlements (Fig. 14).

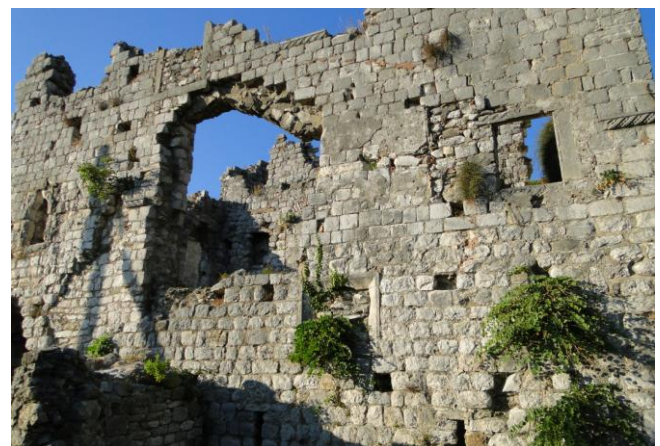
Figure 15: Example of destructive effects occurred on the ancient historical centre of Bar during the 29 May 1979 earthquake

settlements were damaged including all the cities overlooking the Adriatic⁴. Monuments, cultural goods, infrastructures and historical centres suffered damages sometimes irreversible as well as serious losses that have been partly recovered, thanks to international aids and UNESCO. During this seismic event, in many areas rotational landslides and rockfalls were occurred, above all close to Cattaro and Perast sites, where traces of landslides are still more evident (Fig. 15).
